- **Municipal**
- **Size: 44 000 PT**
- **Maximum inflow: 20 000 m³/d**
- **Bio textiles: 3,8 m x 0,96 m**
- **2 basins each with 28 cages à 2 x 2 m each with 64 biotextiles**
- **Total volume of the biological tank: 3 300 m³**
- **Nitrification and denitrification with intermitting aeration**

Because of risen legal requirements the necessity of targeted nitrogen elimination became apparent. In the course of the reconstruction in the years **1999/2000** the fixed-bed material **Cleartec® Biotextil** was installed in both aeration tanks to increase the active biomass. Besides the targeted N-elimination the carbon degradation also increased.

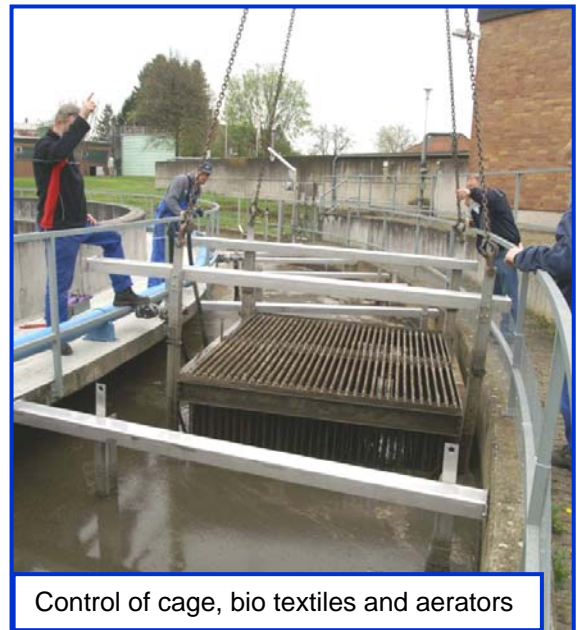
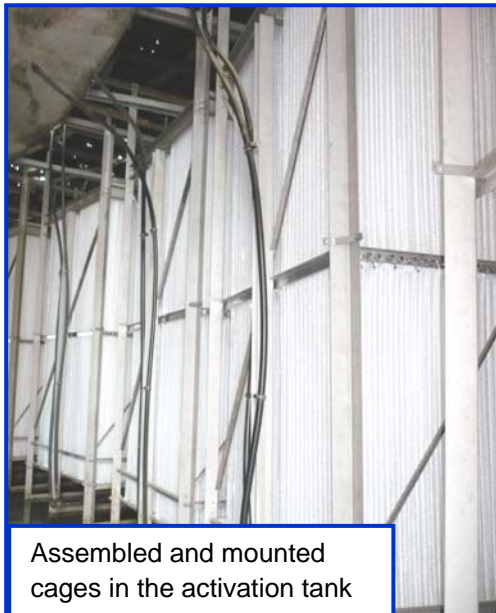
Because of a design failure of the former planner it was necessary to **replace the biotextiles in 2008**. The distances necessary for the optimized function and the long life time of the bio textiles were kept, furthermore the textiles were fixed better through a third supporting loop.

- The discharge values improved again
- Even in the cold winter 2008/09 the discharge values for nitrogen, which are only valid for the warm season were kept
- The **sludge volume index (SVI)** is in the average only about **70 ml/g**
